Dalmakether Burn Spawning Habitat Improvement Project

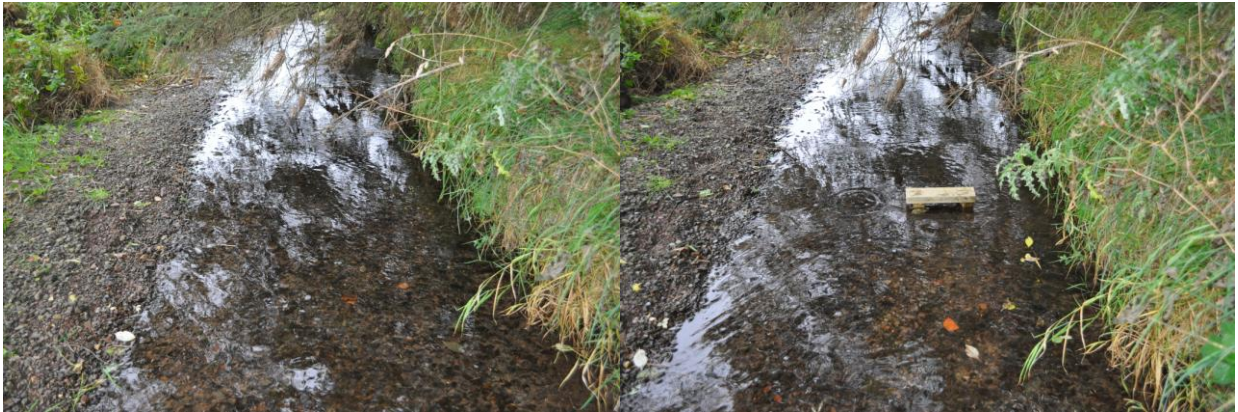
Site 1 E 311064 N 592111

Bed width 2.9m. Water depth uniform 5cm.

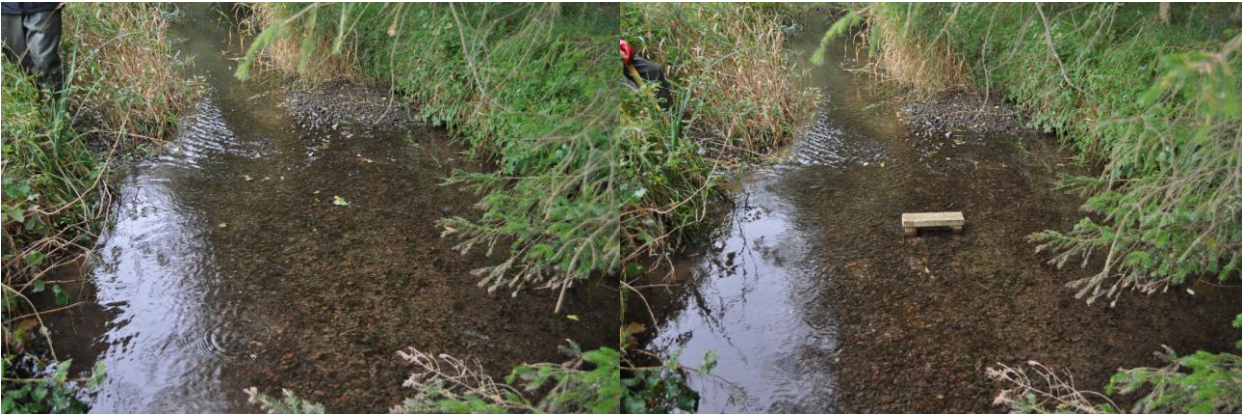
Site 2 E 311034 N 592134

Bed Width 3.1m. Water depth uniform 6cm.

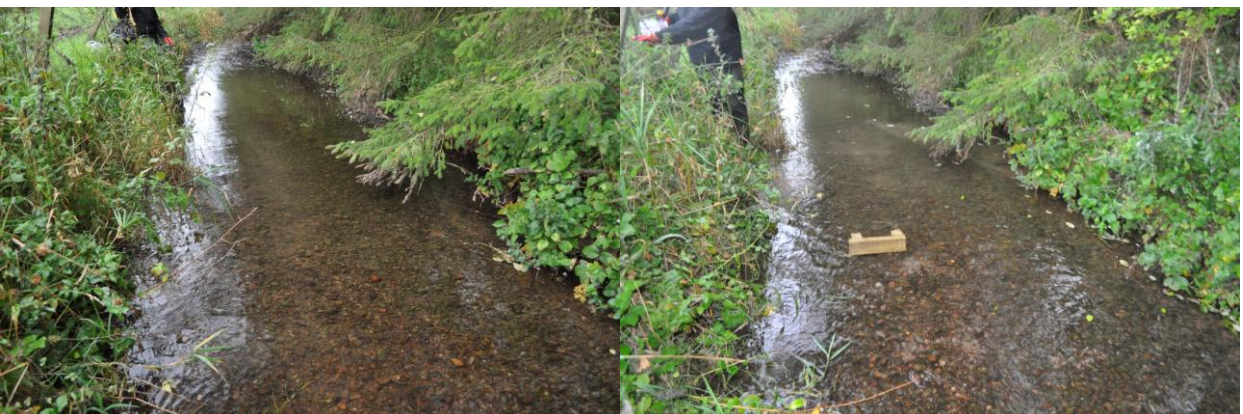
Site 3 E 311016 N 592145

Bed Width 3.2m. Water depth uniform 3cm.
