**Restoring Annan Water**

# **River Annan (Adamsholm)**

*National Vegetation Classification Survey*

September 2015

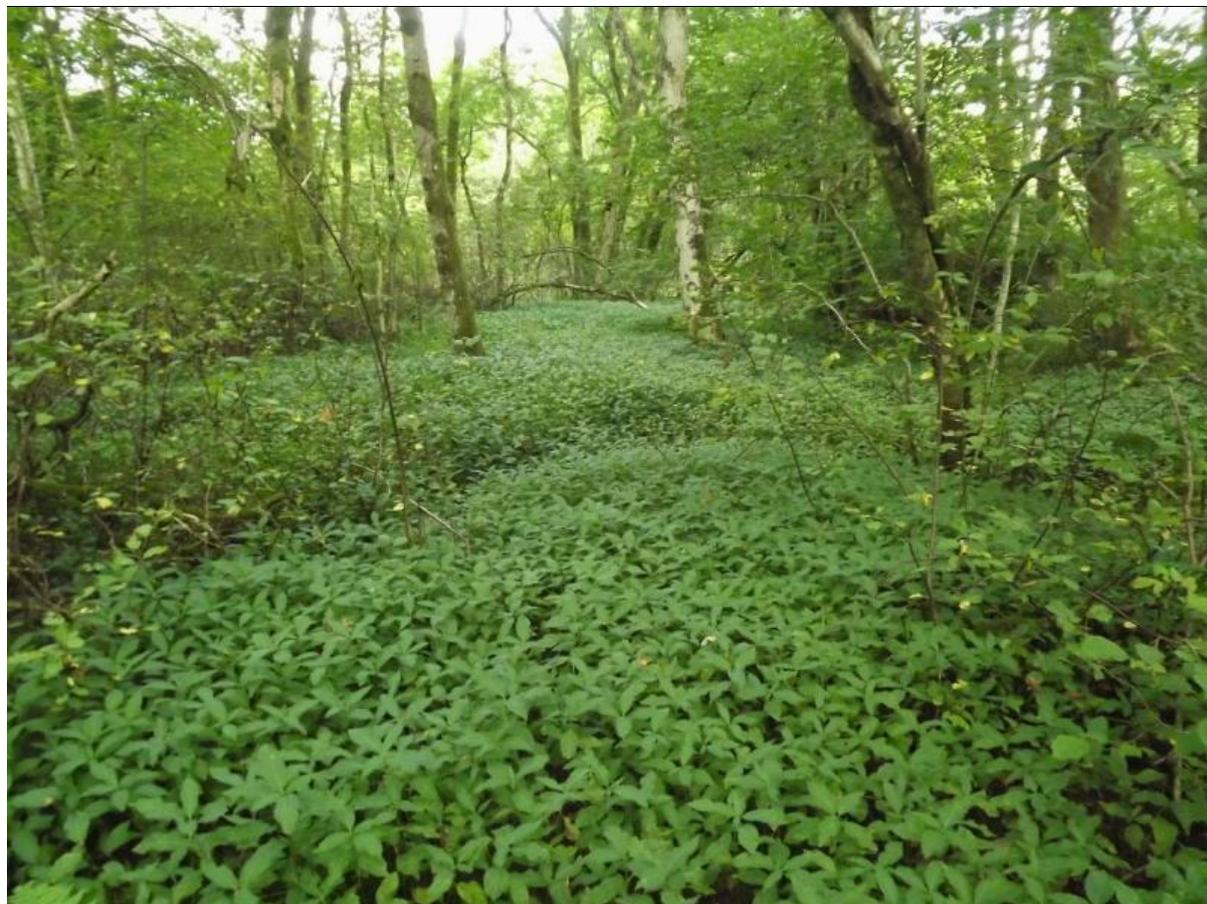
#### a) Typical sub-community

This is the most widespread community occurring within the study area, dominating the island and anywhere that more base-rich substrates are encountered.

The community consists of a high forest canopy co-dominated by *Fraxinus excelsior*, *Acer pseudoplatanus* and *Alnus glutinosa* over an under-tier of *Ulmus glabra*, *Betula pubescens*, *Sorbus aucuparia*, *Prunus padus*, *Corylus avellana* and *Crataegus monogyna*. *Salix cinerea* and *S. myrsinifolia/phylicifolia* are scattered throughout. *Sambucus nigra* is occasional. Within the higher canopy *F. excelsior* and *A. pseudoplatanus* are the most common species. *A. glutinosa* is less common but contributes some of the oldest, most mature trees with tall multi-stemmed specimens consistent throughout.

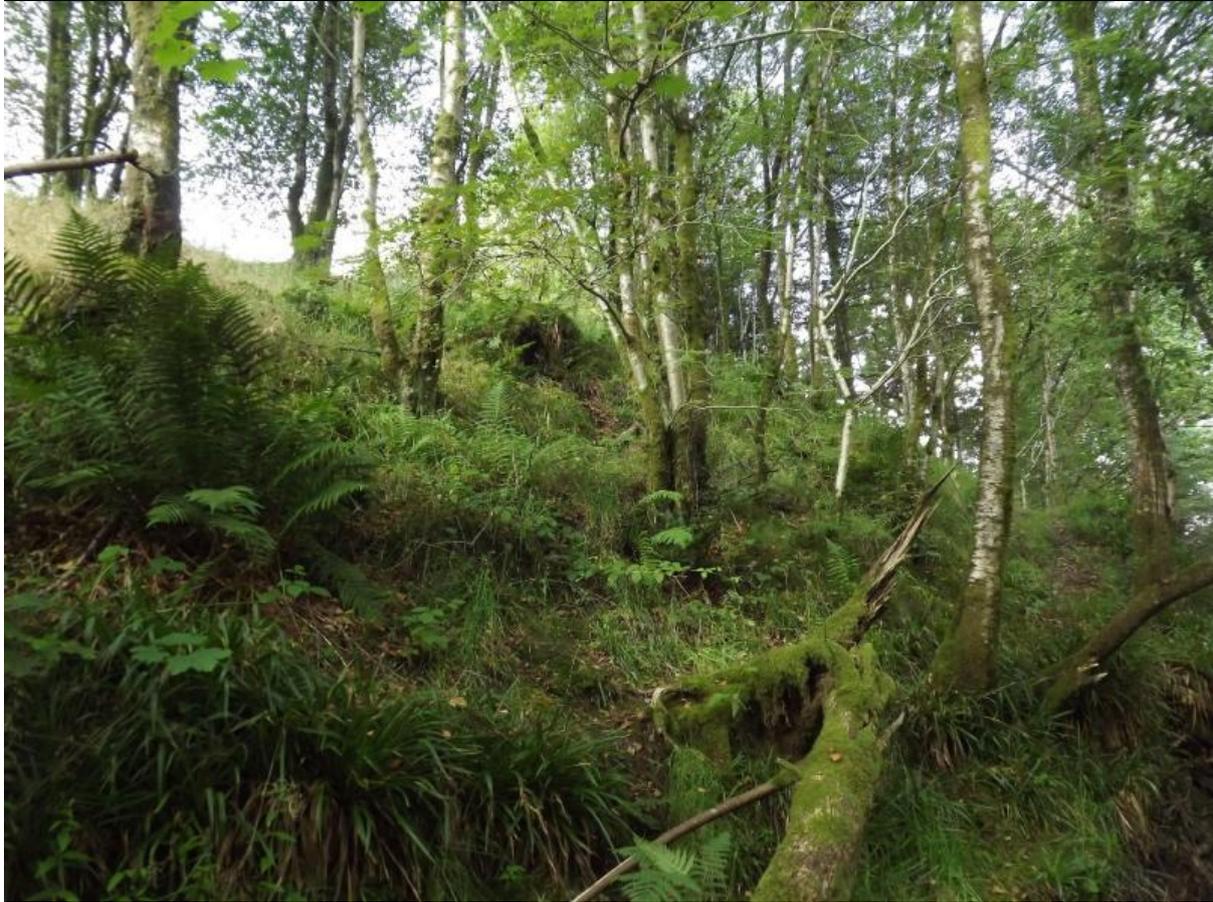
#### c) *Anemone nemerosa* sub-community

This community is far less widespread than the latter. It is found occurring on short, steep banks on the west bank of the river (e.g. NT07576 07115). The community is also more modified than the latter with much disturbance and both planted and invasive non-native species in evidence.

The open canopy is dominated by *Betula pubescens* and *Sorbus aucuparia*. *Quercus petraea* is more occasional.<sup>8</sup> The occasional *Fagus sylvatica* and *Picea* spp. are scattered here and there. There is no under-tier or shrub layer to speak of just a scattering of *Corylus avellana*.

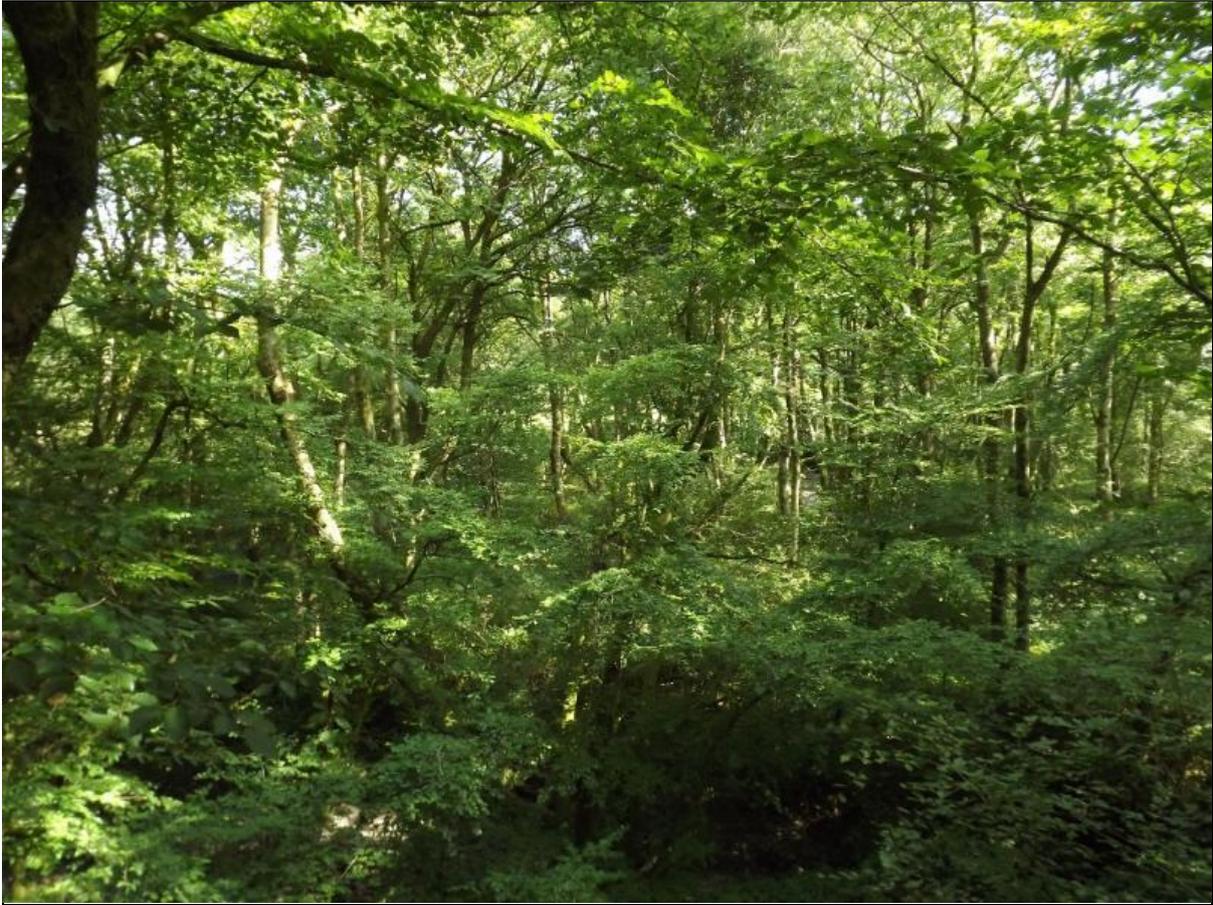
**W9** *Fraxinus-Sorbus-Mercurialis* woodland. Showing the diverse vertical and horizontal layering beneath the high forest canopy with dappled light and mixed shade regimes that characterise the main stand situated on the island. Photograph taken from high up on the opposite bank.

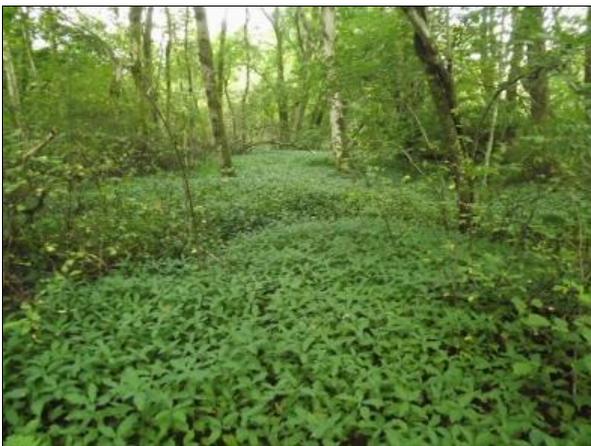
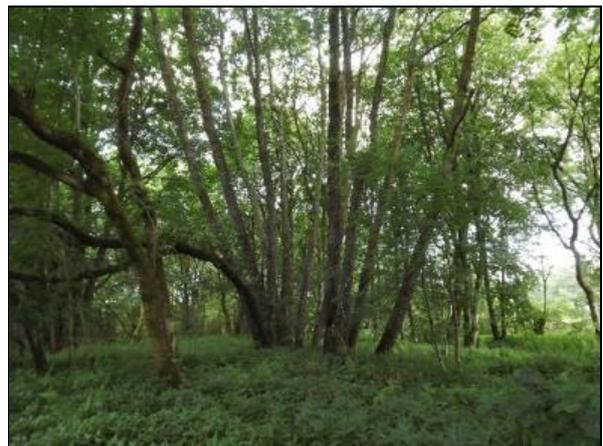
**W9** *Fraxinus-Sorbus-Mercurialis* woodland. Left, carpets of dog's mercury cover the forest floor. Right, large multi-stemmed alder which are a feature of the stand. In places the community grades to **W7** *Alnus-Fraxinus-Lysimachia* woodland.

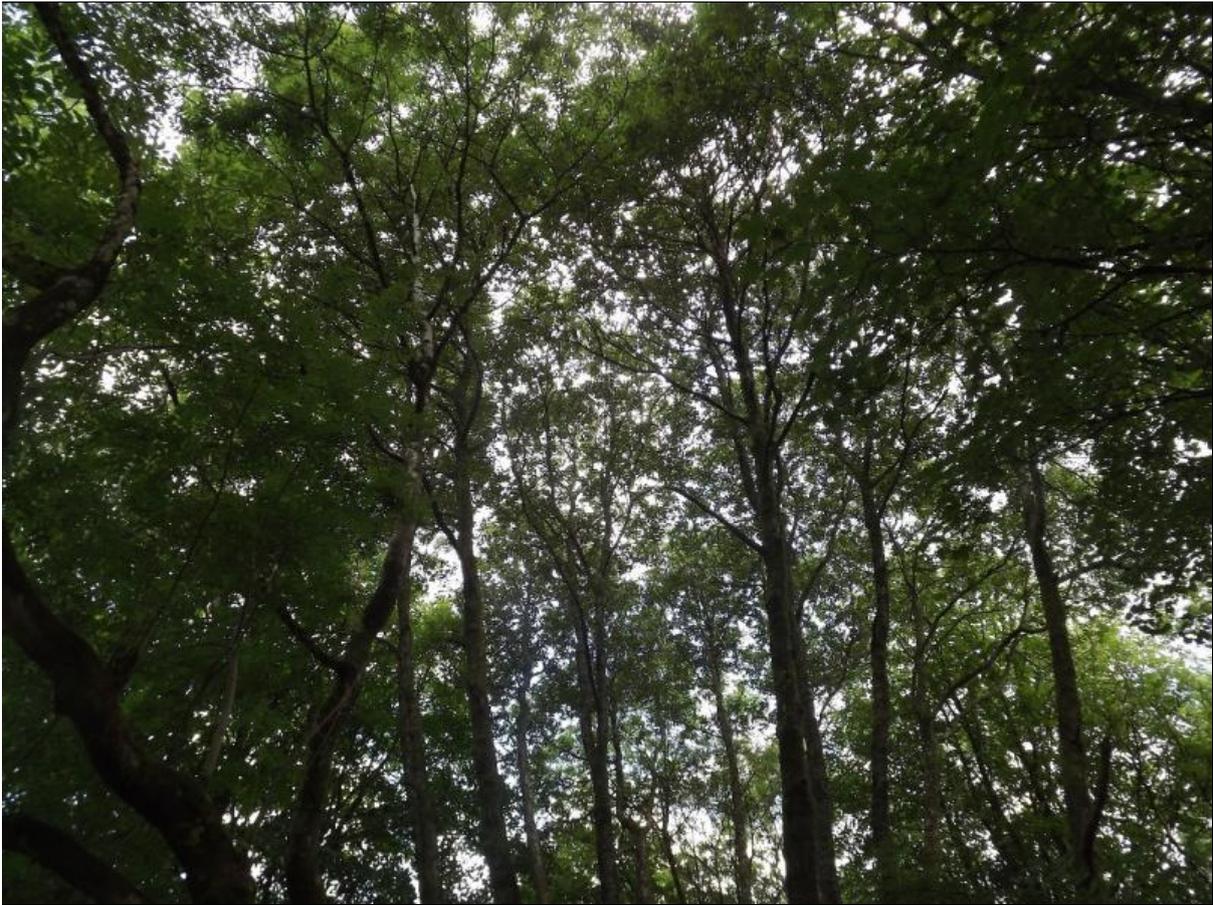
**W9** *Fraxinus-Sorbus-Mercurialis* woodland. Showing the high forest canopy and dappled light created by ash and alder. Should ash die-back do for the ash then sycamore and to some extent, alder<sup>10</sup> are well placed to fill the niche. One can only hope that this is not the case as there are some fine ash trees in the stand and moreover, in terms of natural plant associations, we have already lost the influence of wych elm on the high canopy light/shade regime, the loss of ash too, would render a long established native woodland type replete with all of its own characteristics, bereft of its two key dominant species. In small parts of the island, as here in the photograph, it is pleasing to look up and see a canopy made-up almost exclusively<sup>11</sup> from native trees in their natural setting.

<sup>11</sup> Note: the tree in the top right hand corner is sycamore but other than that the canopy in this little spot consists of ash with occasional alder.

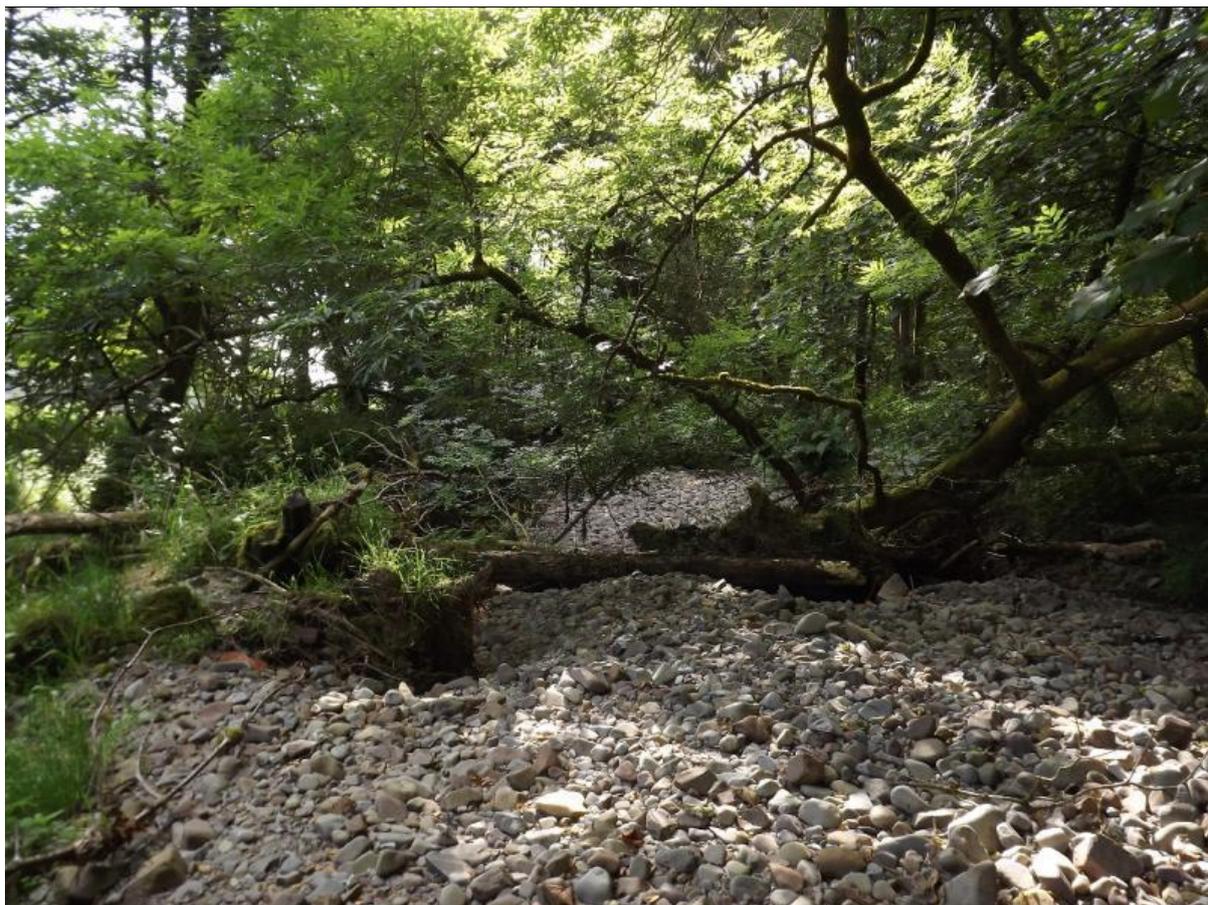
**W9** *Fraxinus-Sorbus-Mercurialis* woodland. Showing the structural diversity and dynamic substrate regime on the forest floor. The regular damage and consequent irregular regrowth caused by flood events creates multiple niches for both flora and fauna. This is further enhanced by the constantly changing substrate condition as the cycle of dumping and lifting of alluvial material after each flood creates new conditions for plants and animals to exploit. The latter is very much a feature of more natural floodplains and is scarce in the region.

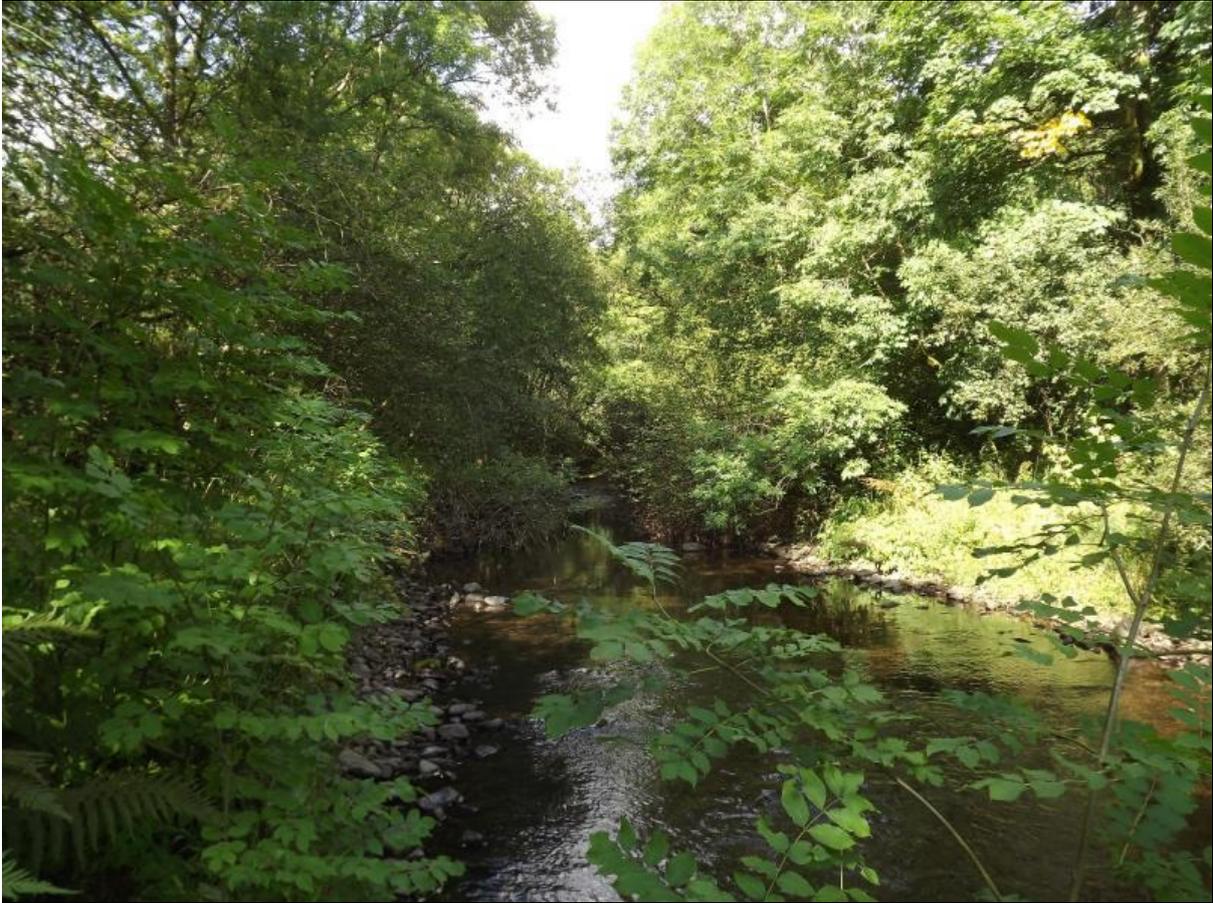
**Channel features.** Looking upstream from the west bank showing the well vegetated margins and the intact channel. This is good quality habitat and the type of habitat that is so badly missing from so many of our burns and rivers. Unrestricted access by farm stock and the lack of wide enough uncultivated margins has led to the loss of such habitat up and down the country. Fortunately it can be remedied provided enough land is set aside within river corridors to allow functioning natural habitat such as this to get firmly and permanently established.<sup>12</sup>

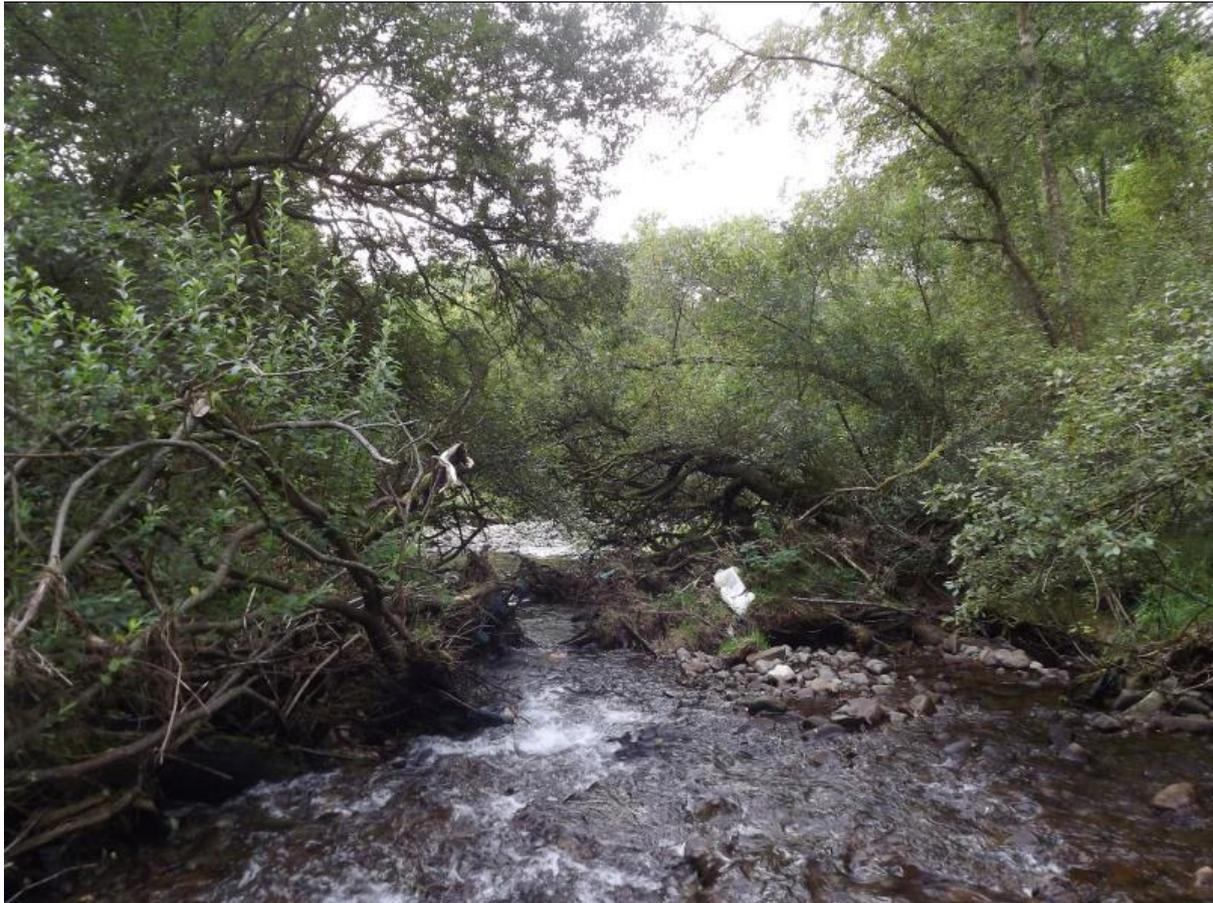
**Channel features.** Natural ephemeral and partial blockages in narrow necks such as this are a key feature of natural river systems. Such features are now very rare within our upland rivers and are often actually cleared in the name of fishery (primarily salmon) management.<sup>13</sup> Such intervention goes directly against the principles of ecological restoration whereby the aim is to encourage natural, dynamic ecosystems governed principally by natural processes. Under natural conditions, long gone species such as European beaver would've played a key role in creating such diverse flow systems, complete with small ponds, backwaters and shifting channels. Both fish and beaver co-existed happily for millennia and this is perhaps well worth remembering when we consider management options in regard to natural, short-lived and partial blockages such as large woody debris brought downstream by flood events.<sup>14</sup>

As witnessed in the photograph, such features can gather unsightly litter and general agricultural and forestry detritus but this speaks more of us and our behaviour than of natural processes.

<sup>13</sup> Note: unnatural, permanent and near complete barriers such as weirs, caulds etc should, of course, be either removed completely (the ideal option) or modified to accommodate wildlife and allow more natural flow and temperature regimes etc to develop.

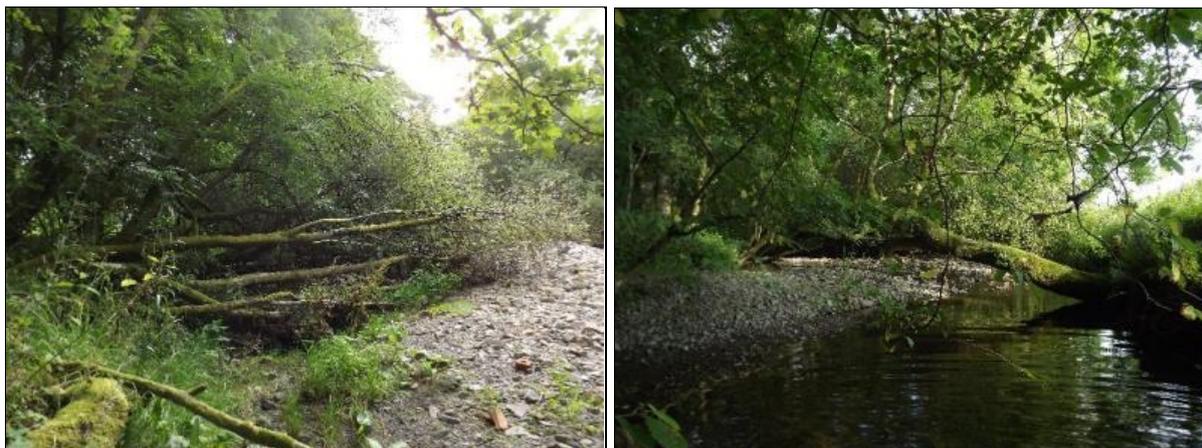
**Channel features.** Left, fallen trees directly in channel. Right, backwater channel/oxbow lake on east bank of the island. Both are typical features of more natural and undisturbed river systems and are an example of the quality of the habitat on this stretch of the river.

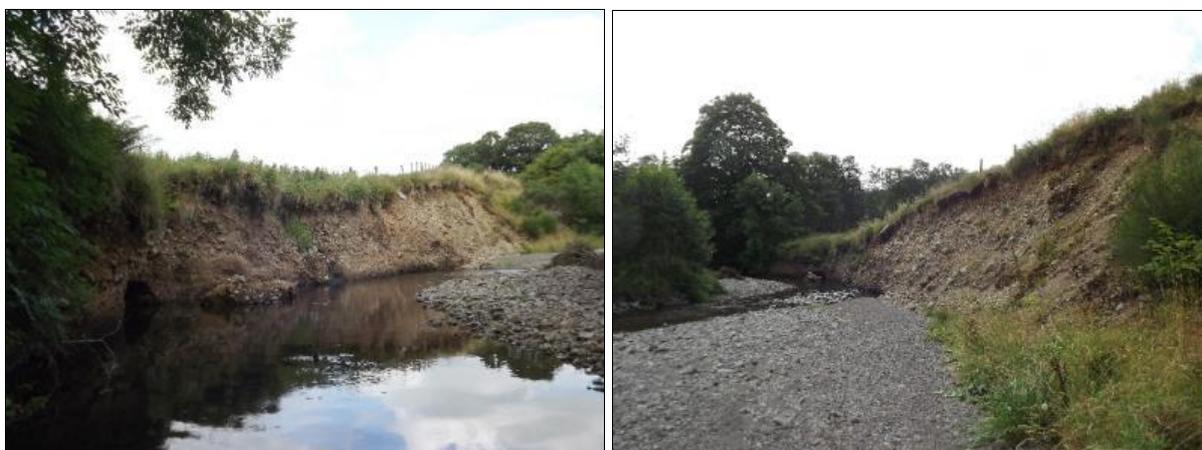
Channel erosion, a phenomenon so typical of so much of our watercourses throughout the country, is not a serious issue within the study area. There is one eroded bank on a bend of the river immediately at the upstream limit of the study area (NT07564 07180)

**Erosion.** Erosion on the west bank of the river at NT07564 07180 at the upper limit of the study area. Left, looking upstream, right, looking downstream. Note how close the fence is to the top of the eroded cliff and the lack of marginal woodland. Although erosion is one of the key (and welcome) natural processes governing river systems, accelerated erosion related to anthropogenic land use such as witnessed here is very damaging. Although remedial construction work such as netting or revetment can remedy the problem in the short-term, the longer-term solution is to allow a wider riparian corridor from which land exploitation is excluded<sup>15</sup> and natural processes allowed to run their course. In such situations, even when serious erosion events do occur, the impacts are less catastrophic and the recovery much quicker.

<sup>15</sup> Note: allowing for drinking access for stock and other such limited activities.

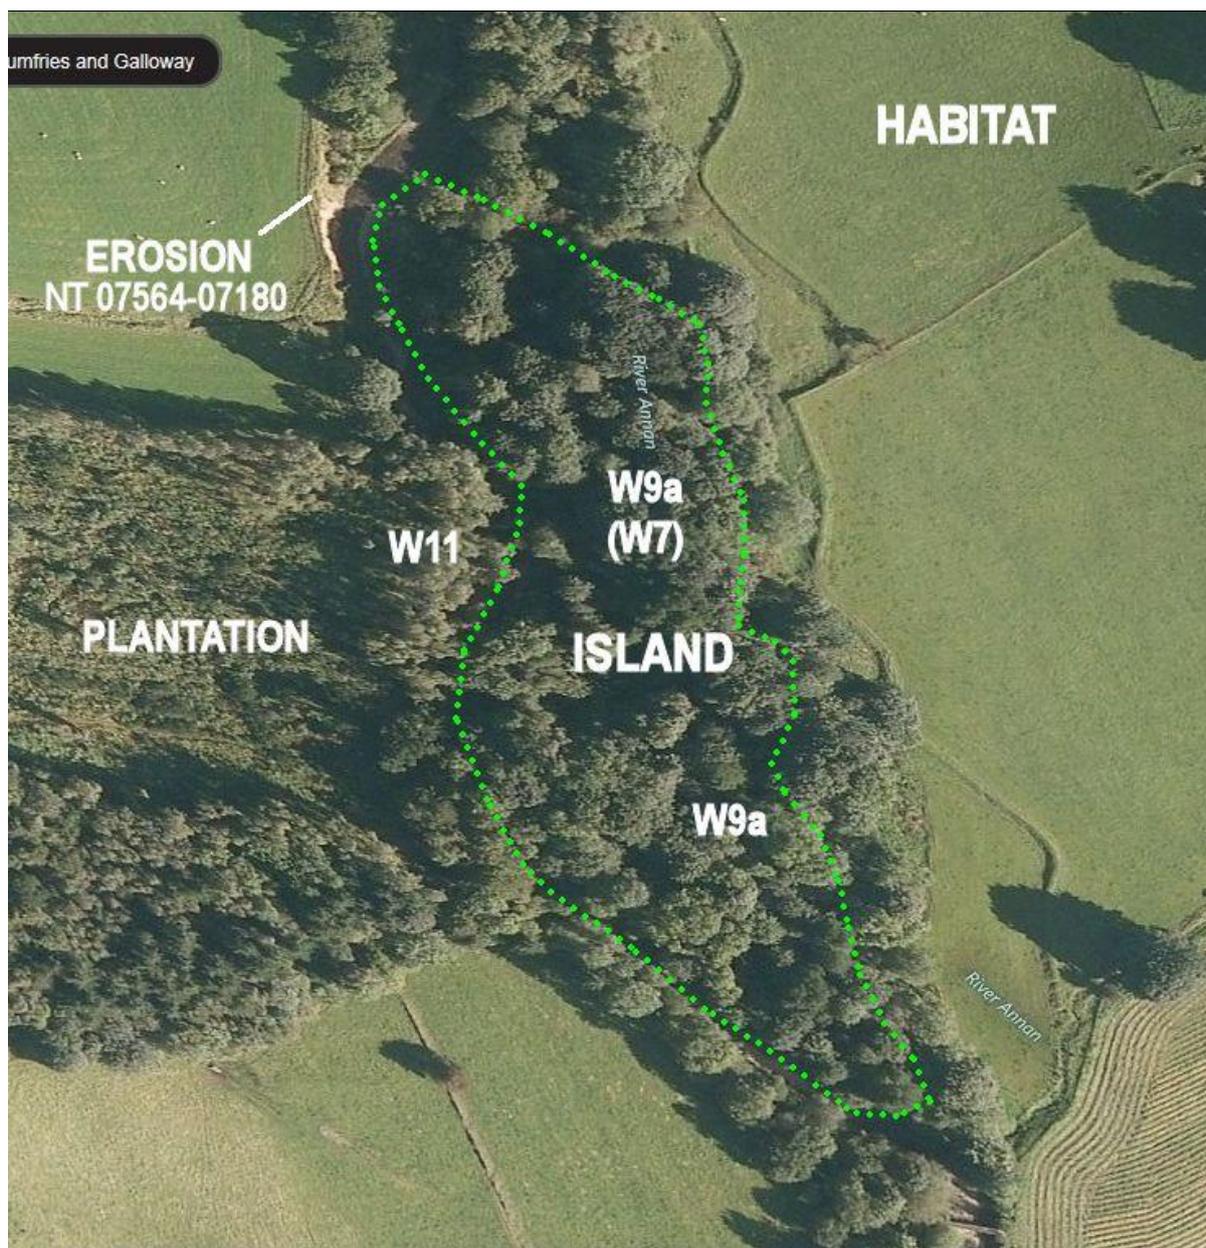
**Habitat.** Showing NVC communities, estimated outline of the island (in green) and erosion event (aerial image taken from Bing).
